Scientific Crash Investigation
A First Step In Achieving Road Safety

Dr. Rohit Baluja

**ACCIDENT INVESTIGATION/ RECONSTRUCTION
& RECOMMENDATIONS OF DEORI VILLAGE ACCIDENT**

DEORI VILLAGE

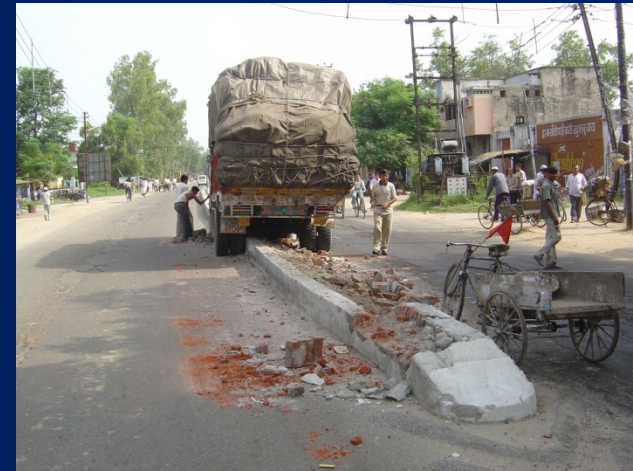
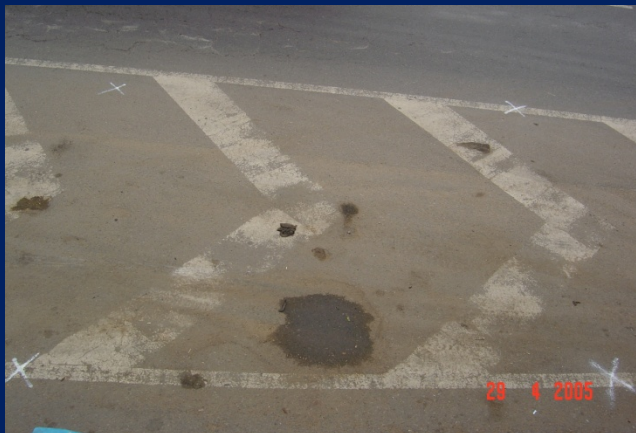
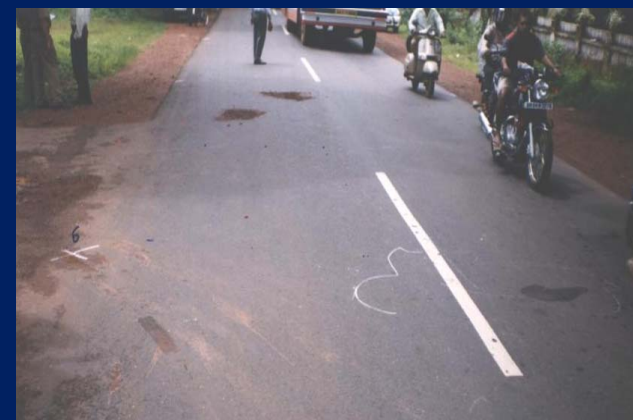
- Damage to road surface,
- Rest Position of all involved vehicles & victims
- road markings and signing together with any defects or obstructions.

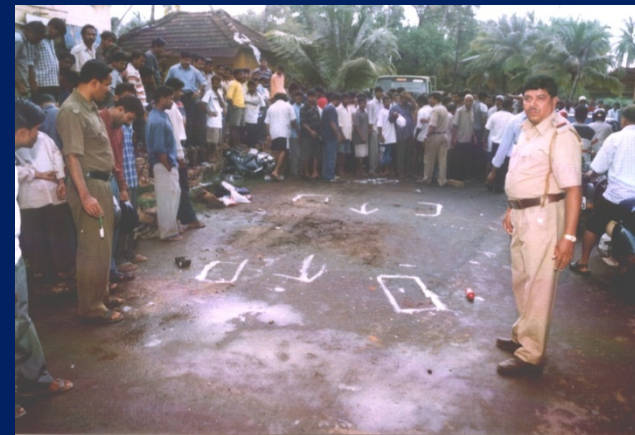
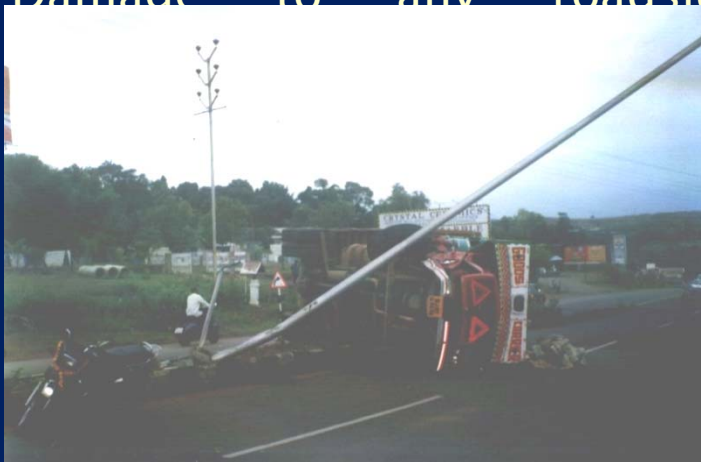
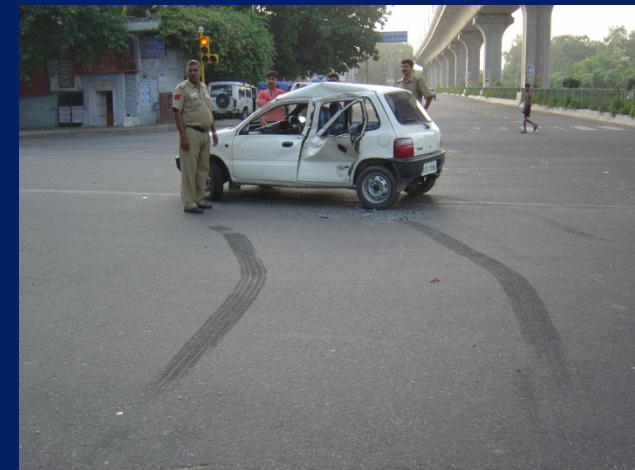
- Exact positions of any tyre skid marks, fluid trails, scuff or scratch marks, blood stains made in or on the road or verges, pre collision or, as a consequence of the collision including dimensions
- Damage to any roadside

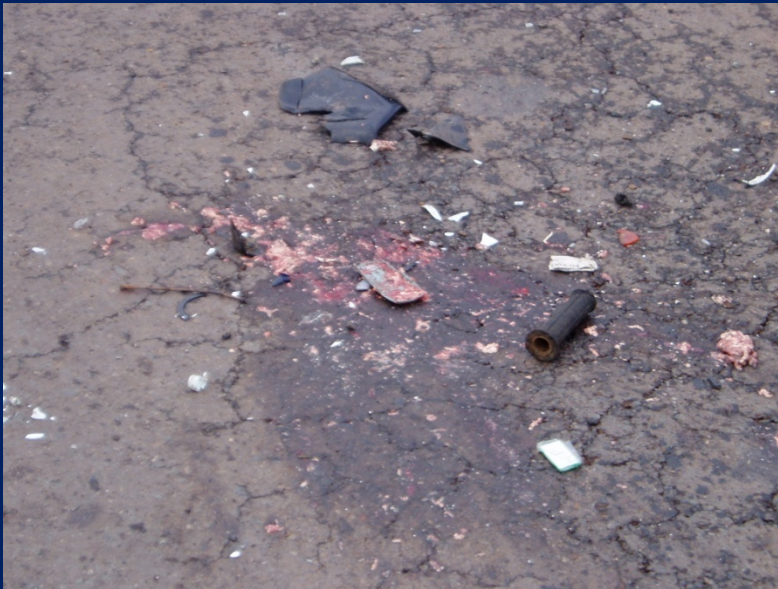
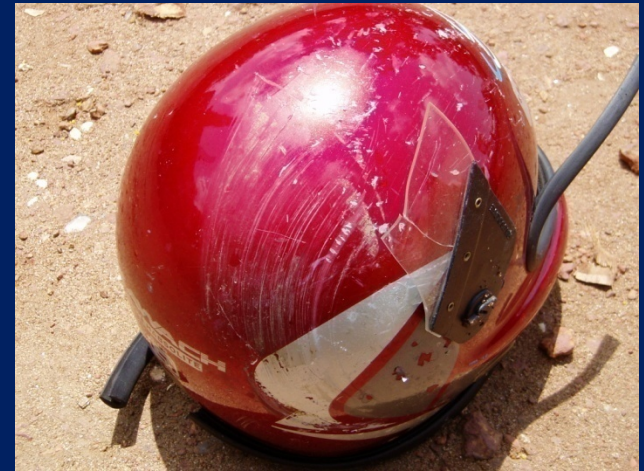
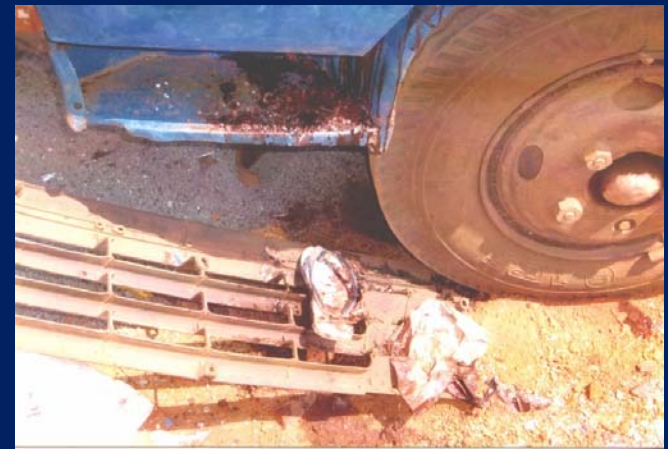
- Position and damage on other material, debris, body or vehicle part lying on the road

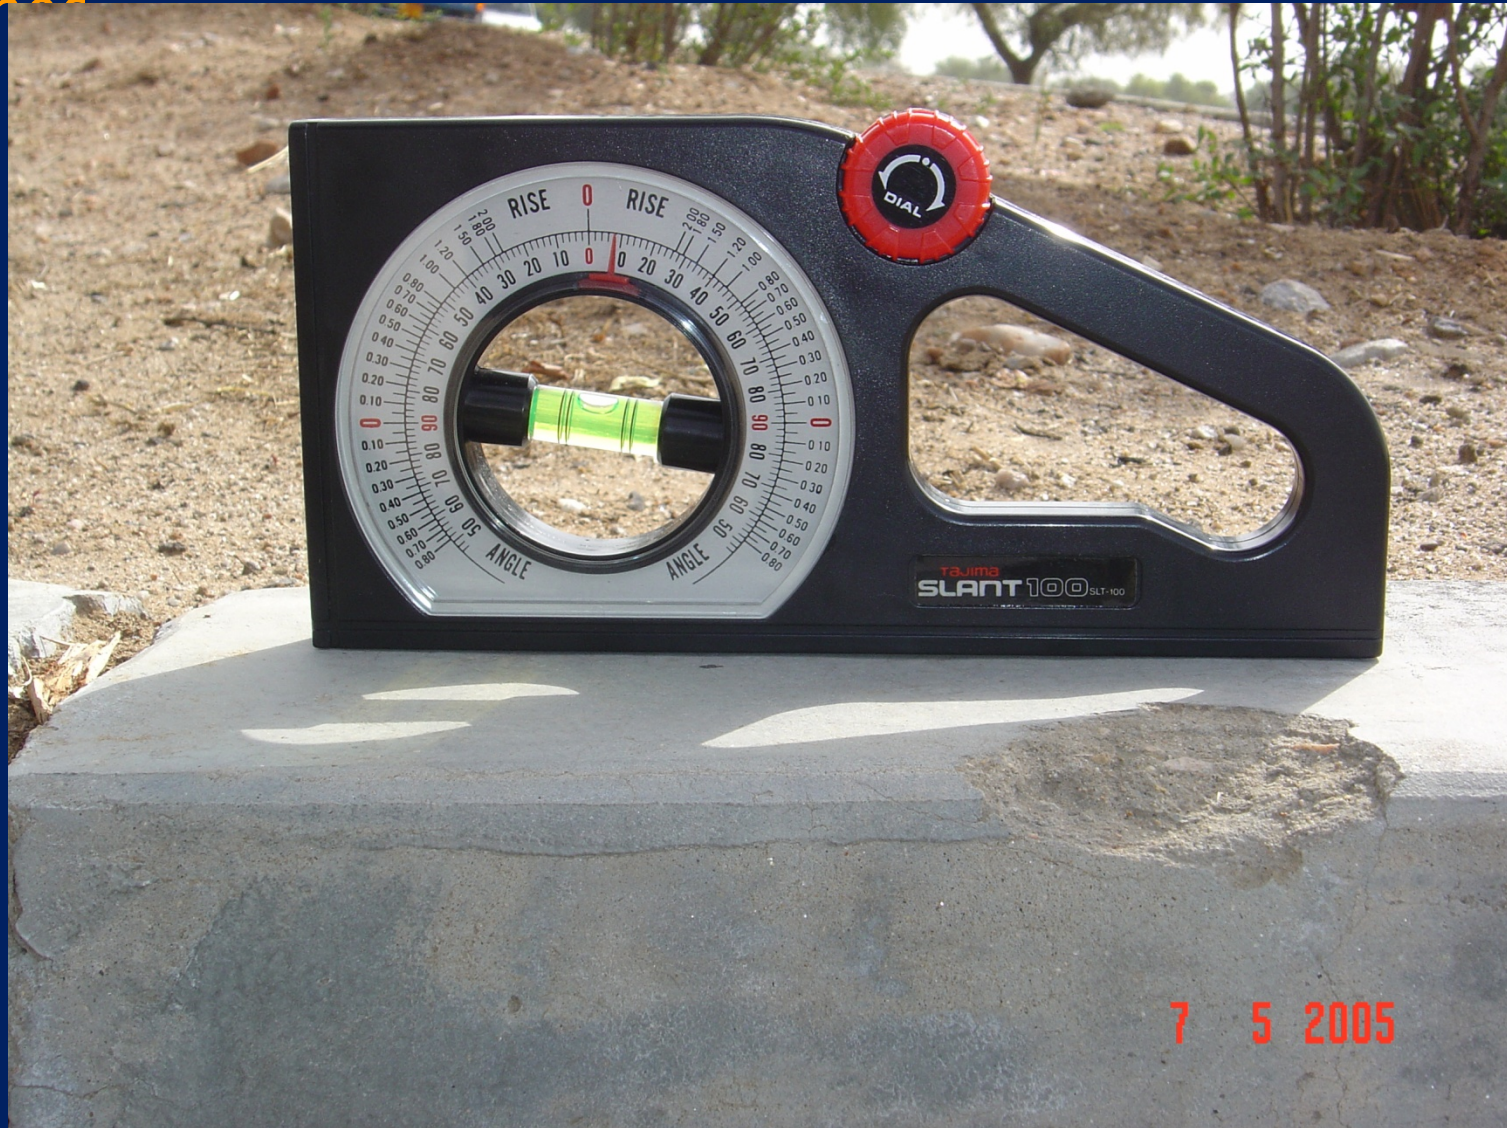
Measurement of gradients, road cambers and sight lines

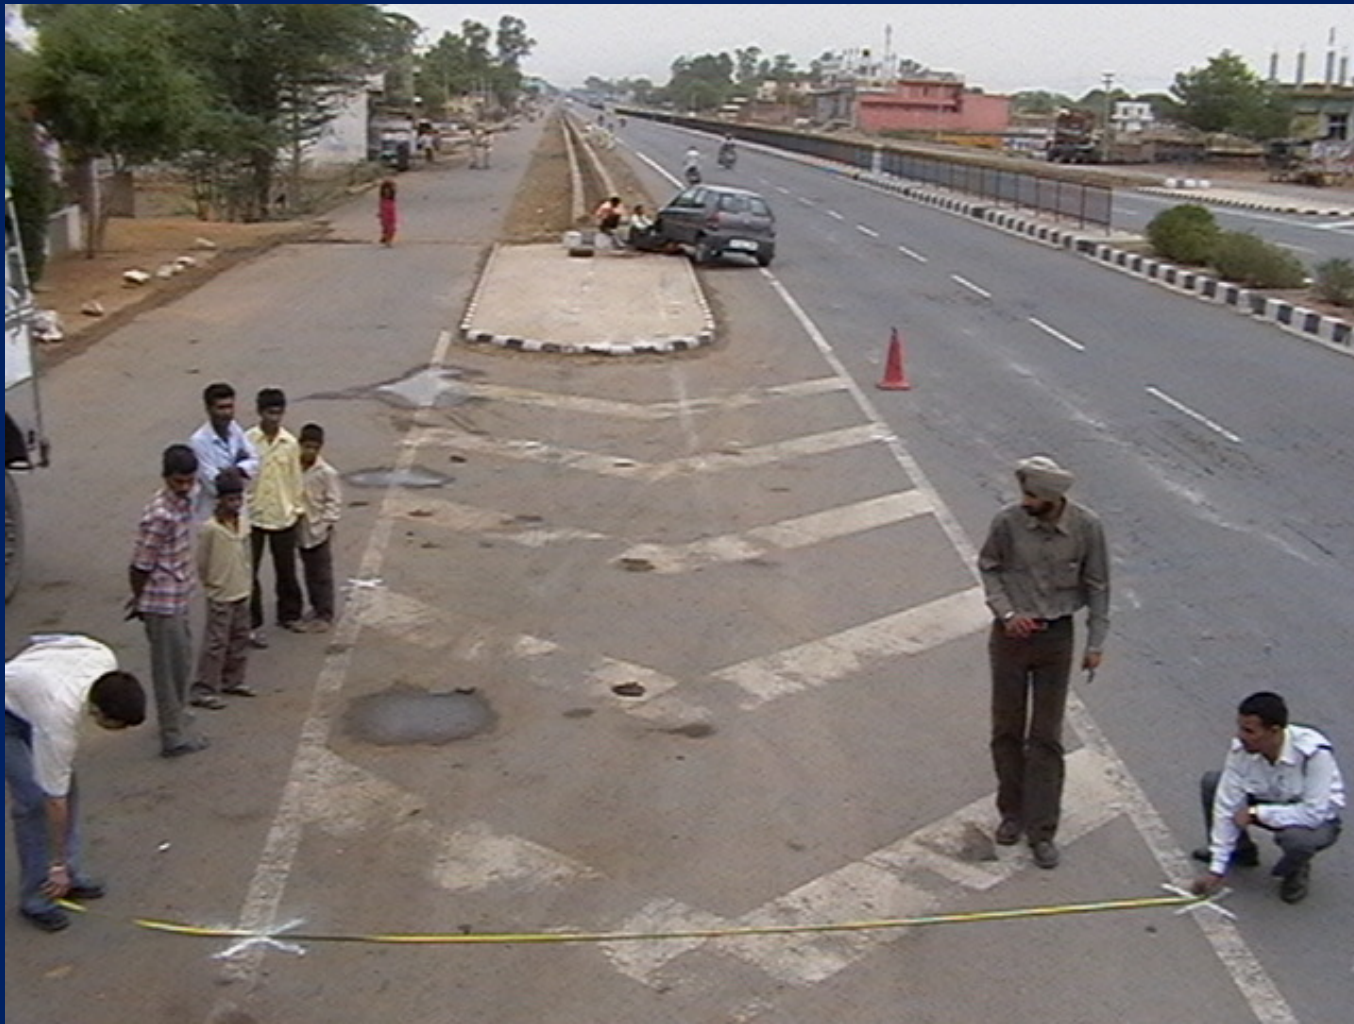
Additional measurements and photographs of vehicle and scene

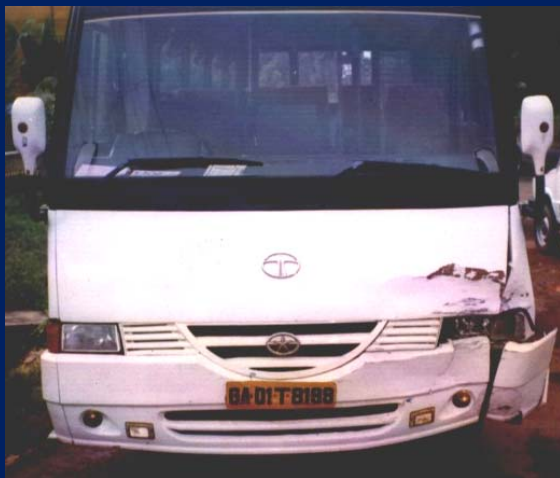
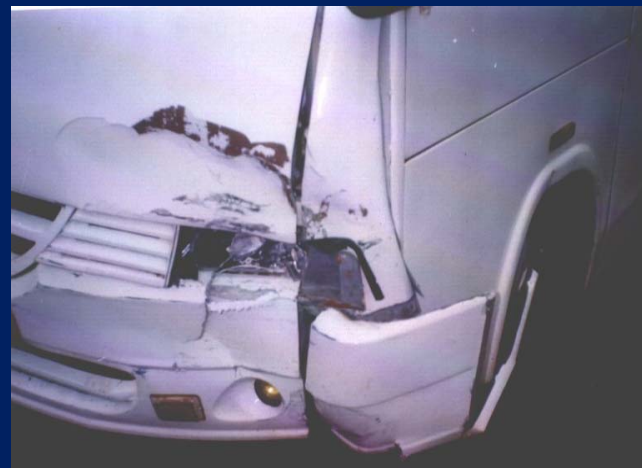
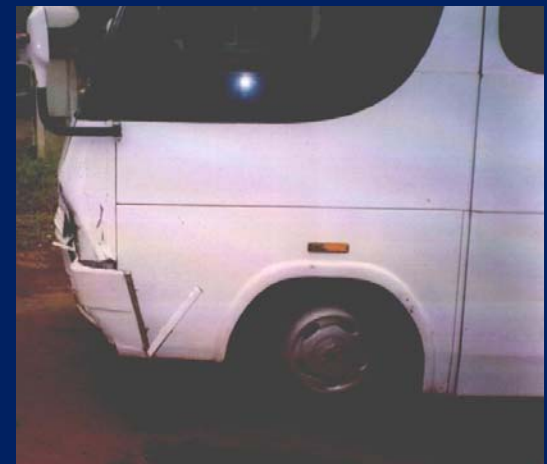
- Position of damage and contact marks to vehicles.

Vehicle damage intrusion measurements that may assist in vehicle speed estimations

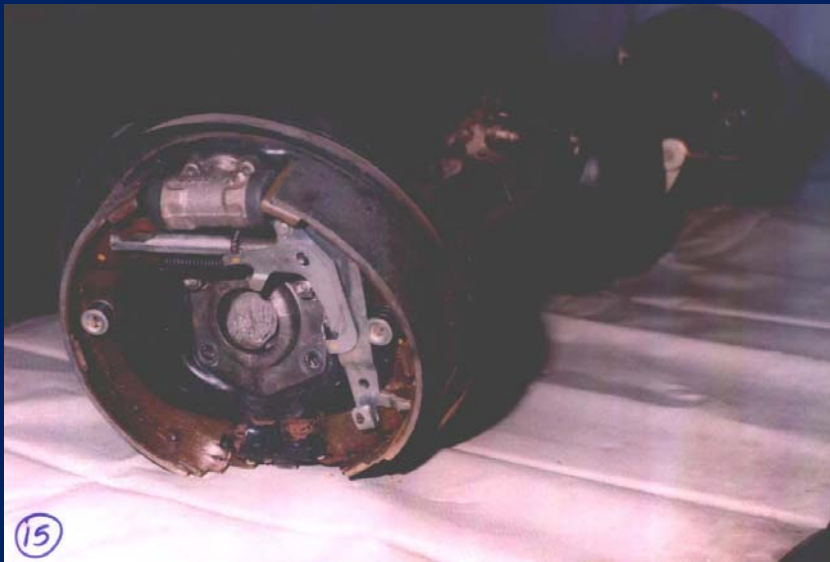
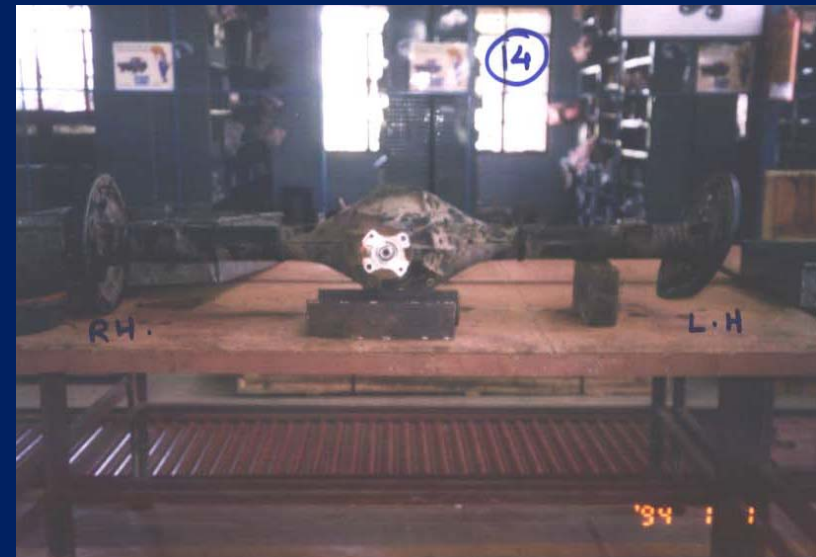
- Complete Mechanical Inspection of the vehicle

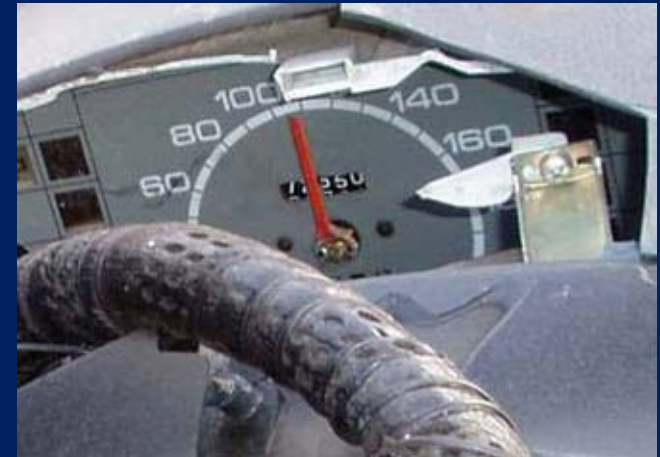
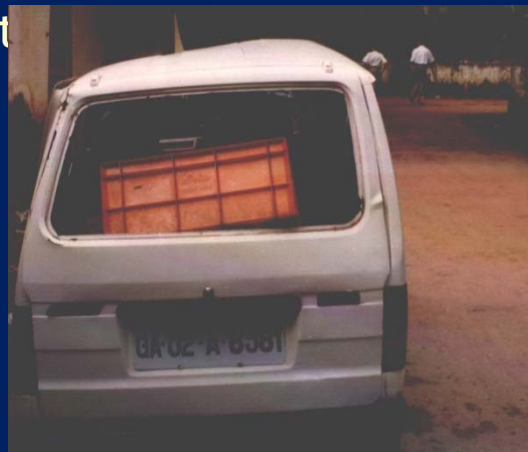
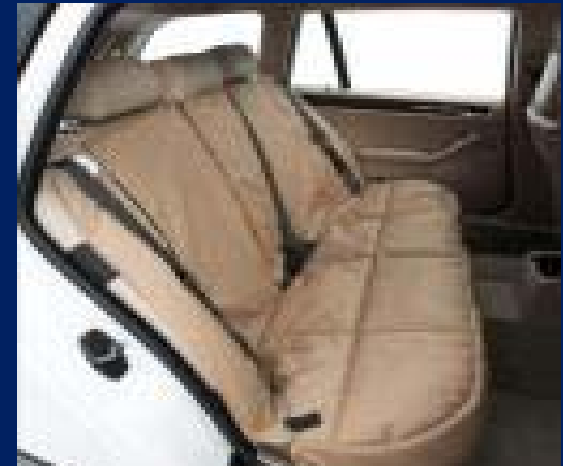
- Examine and note the position of control systems within the vehicles, i.e. light switches and gears, speedometers. Also, note the condition of the seatbelts.
- Examine and note of within the vehicle

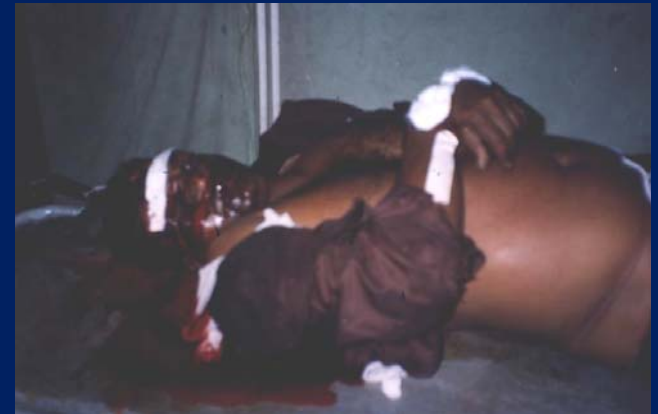
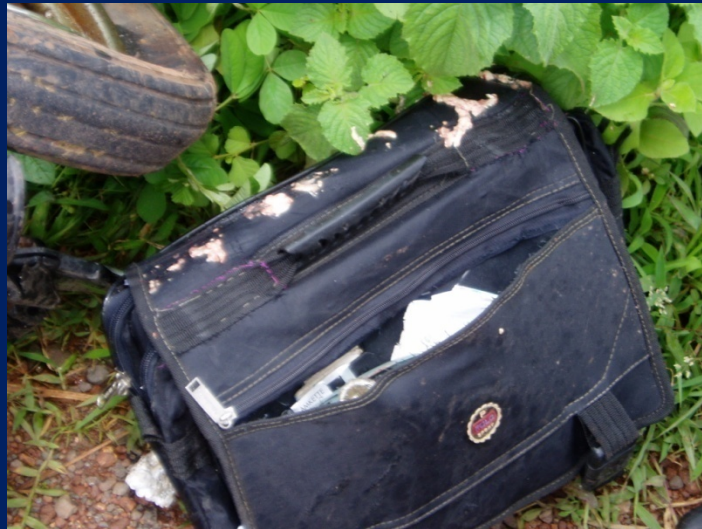
- Details of the injuries
- Examine and note other materials for ex. Clothes, accessories being carried by the victim etc.

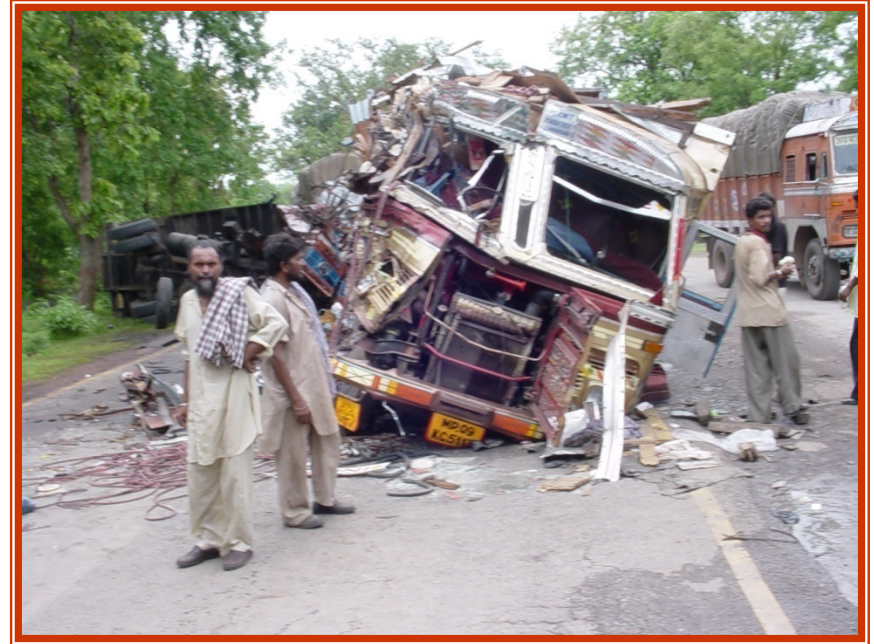
The badly damaged Contractor's truck after the collision.

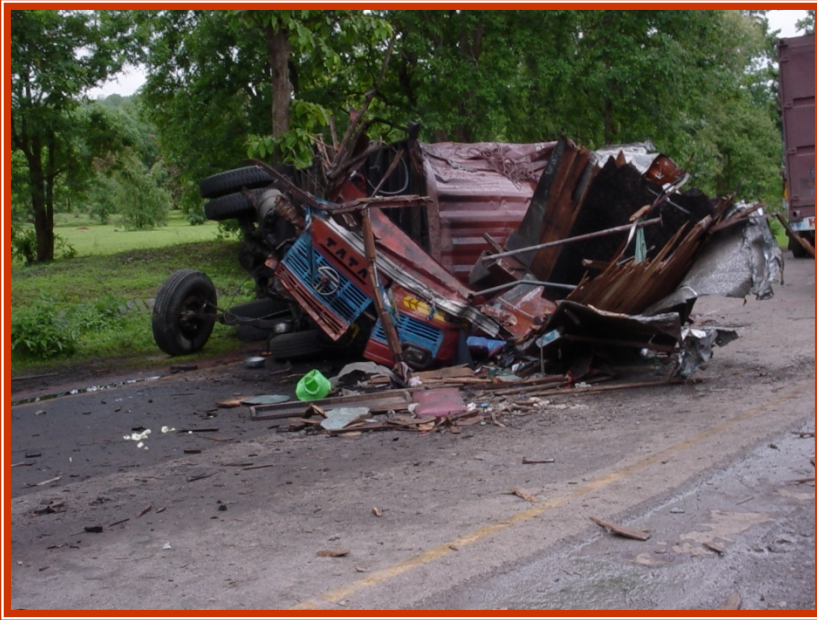
The badly damaged truck after the collision.

The Container containing the finished goods seen turtled due to the impact of collision.

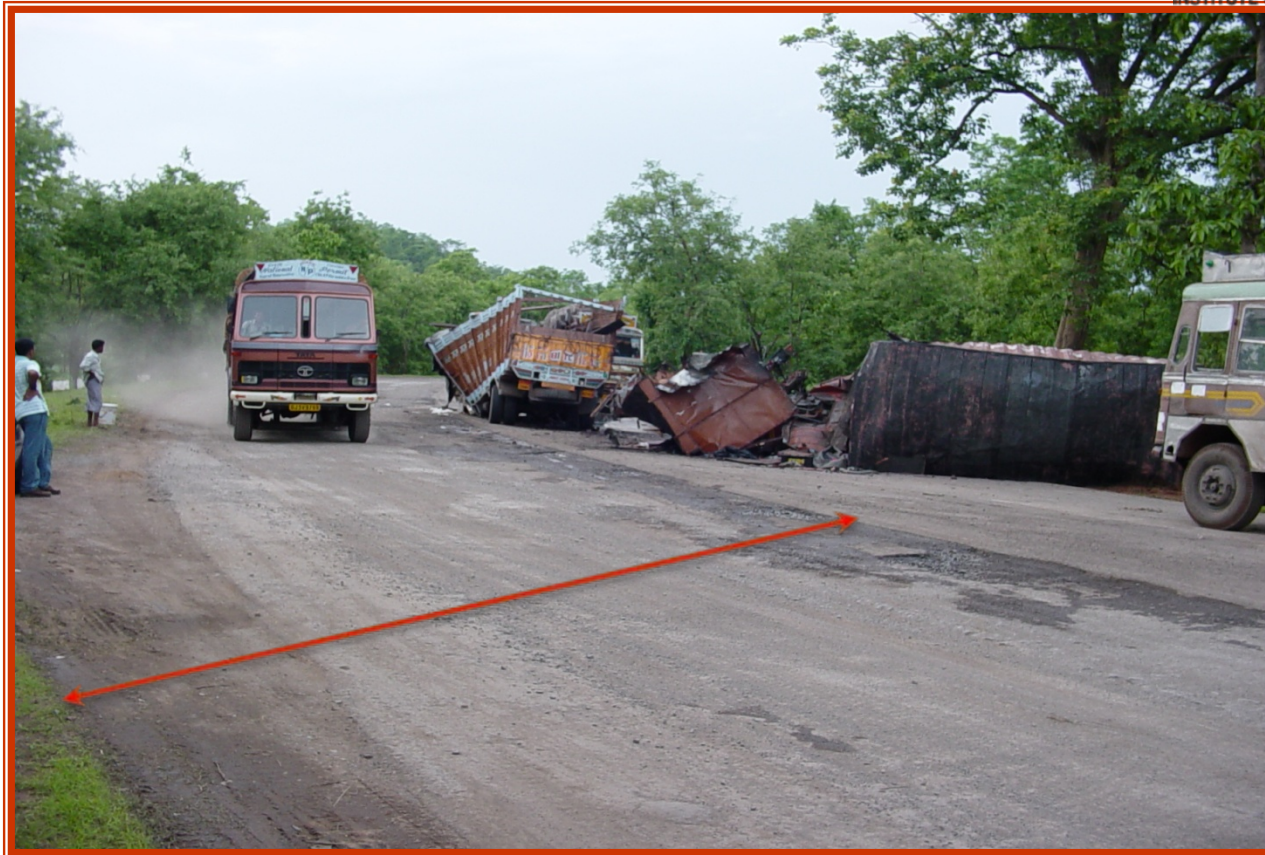
The misleading crescent shaped hard shoulder leads drivers to believe that the road is wider than what it actually is.

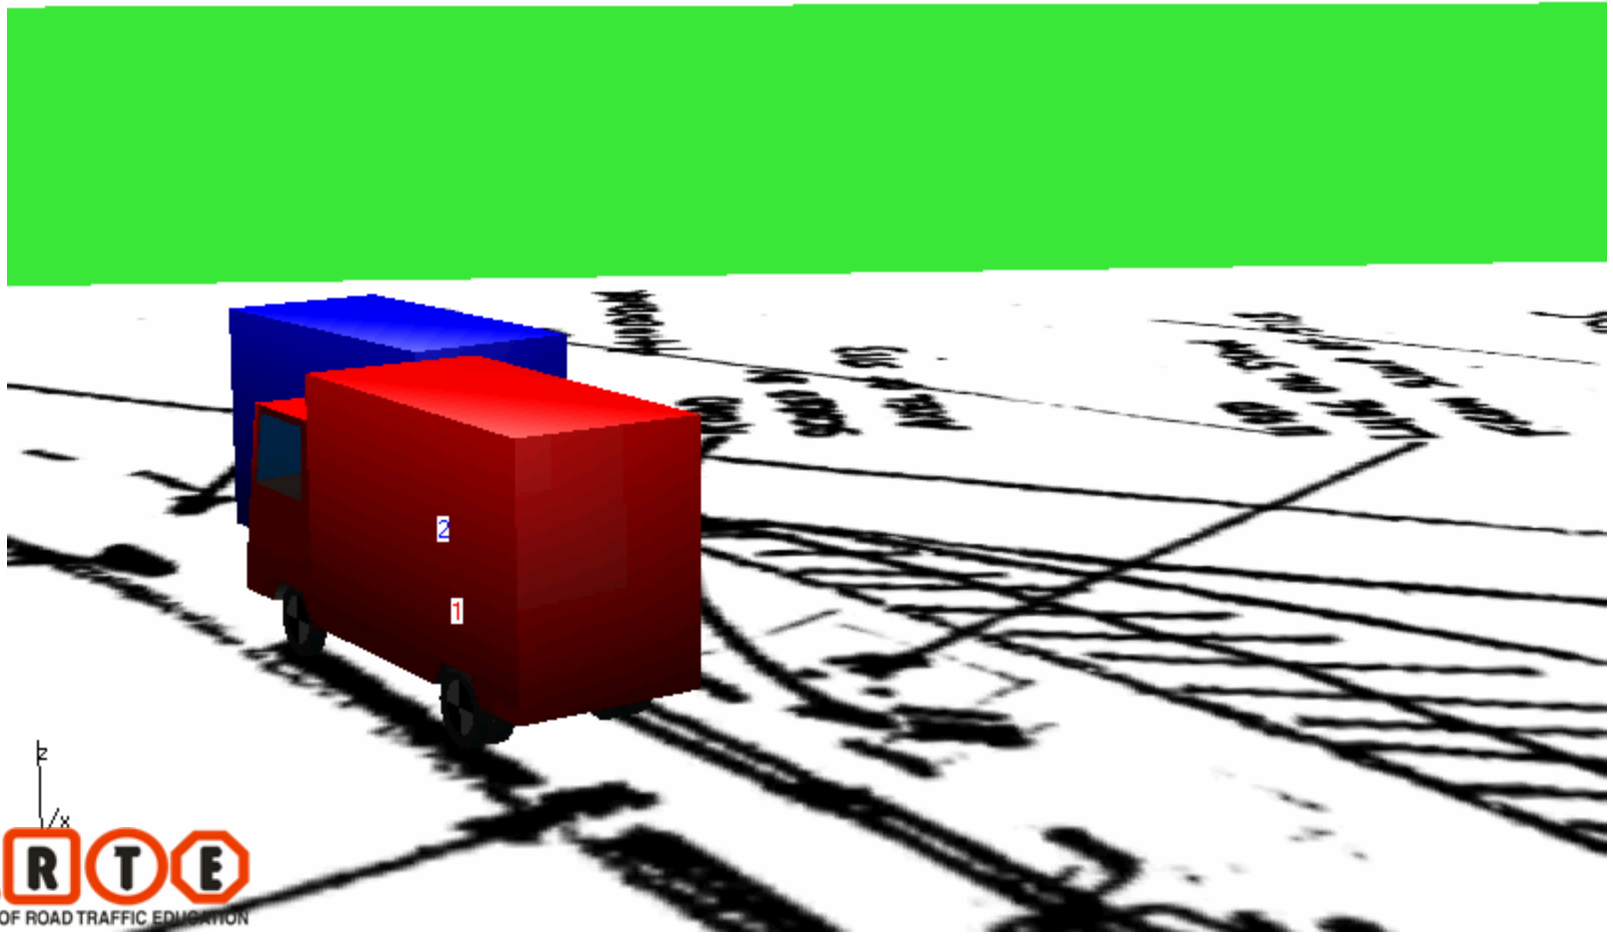
3-D Simulation of the Accident showing speeds of the vehicles at the time of collision

t=0.00 s
v1=50.0 [km/h]
v2=60.0 [km/h]

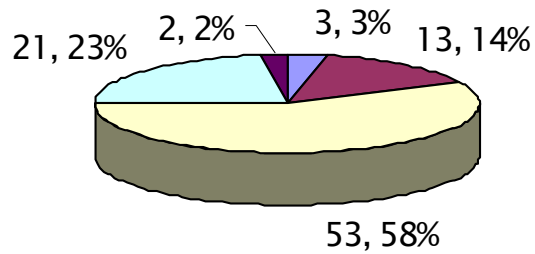
Traffic Volume moving towards Raipur
(1240-1340hrs.)

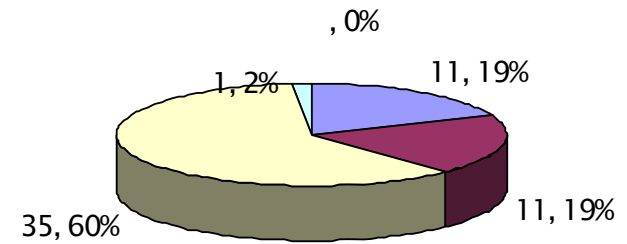
Traffic Volume Moving towards Nagpur
(1240-1340hrs.)

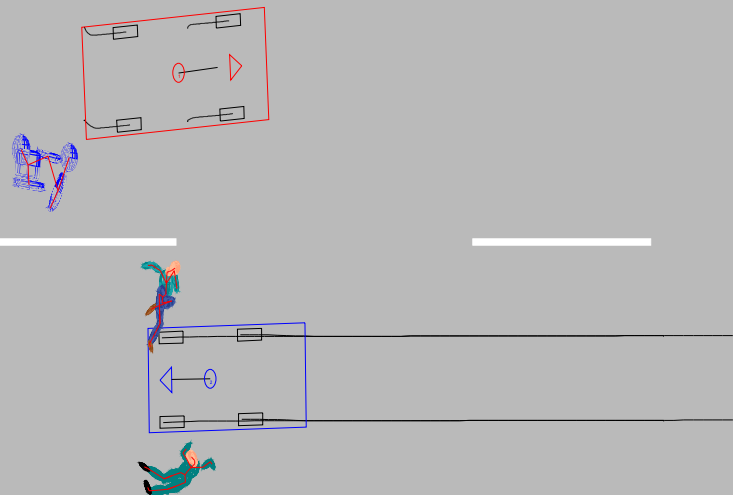
Three Dimensional Simulation of Accident

t=0.00 s
v1=0.0 [km/h]
v2=60.0 [km/h]
