Revolutionizing Road Infra with Modern Equipment, Technologies, Sustainable Materials and Policy Guidelines

A New Technology First Time Used in India for Improving the Riding Quality of a Newly Constructed Concrete Expressway: A Case Study

*Dr. Rakesh Kumar, Chief Scientist
CSIR-CRRI, New Delhi*

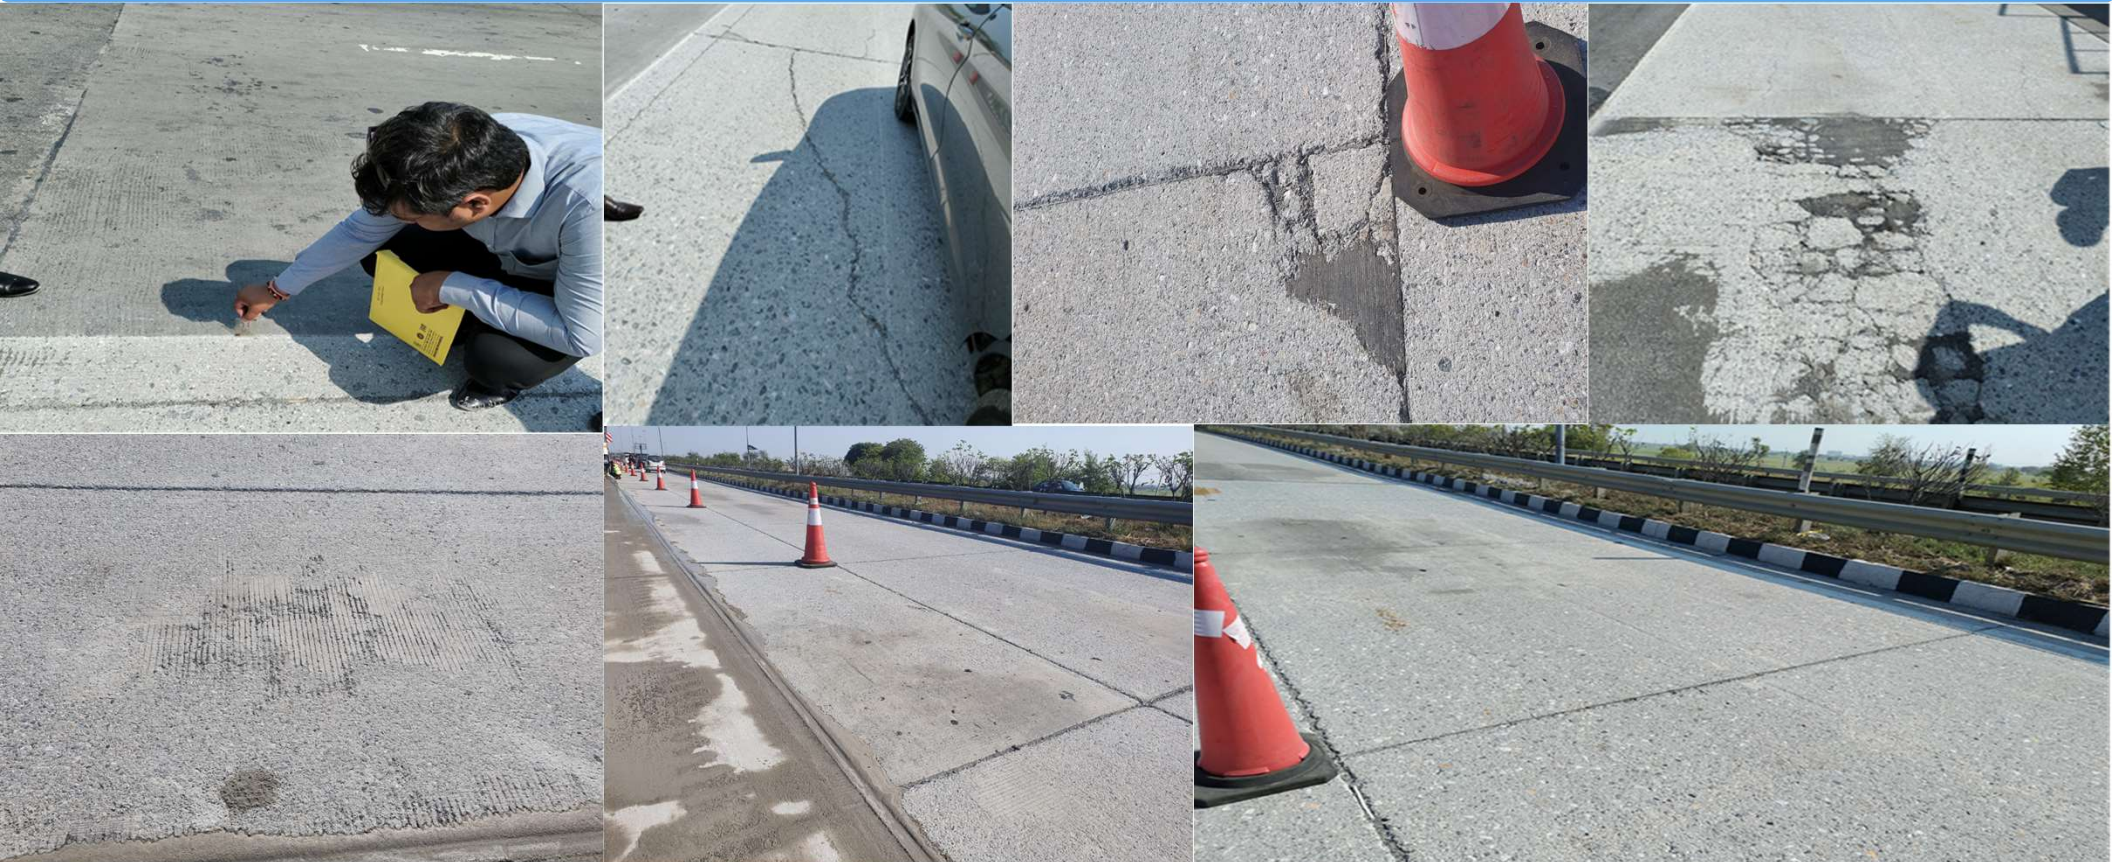
Typical views after milling of the concrete pavement surface

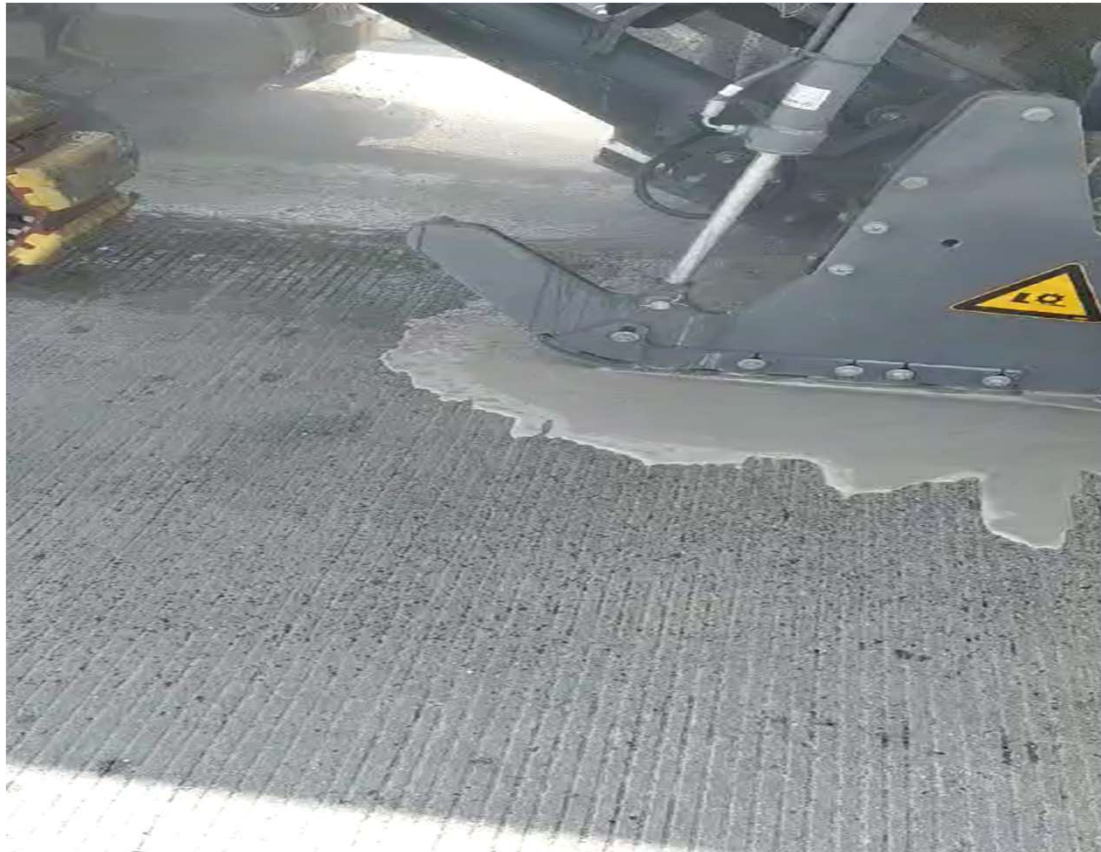
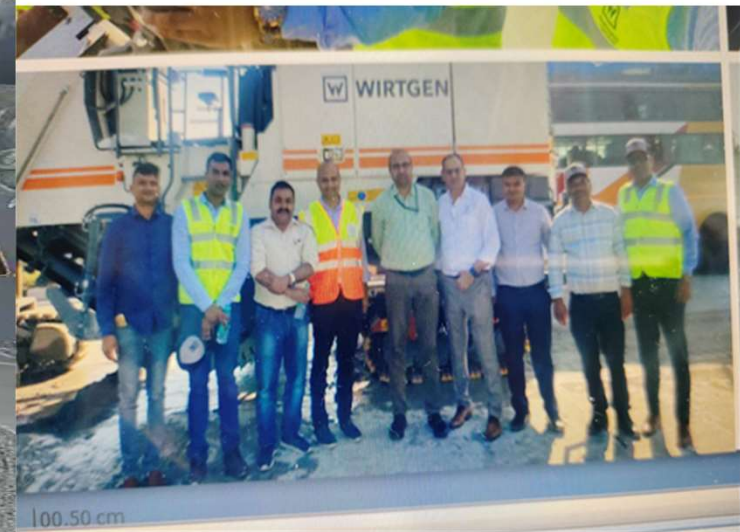
Macro-milling of the concrete pavement surface

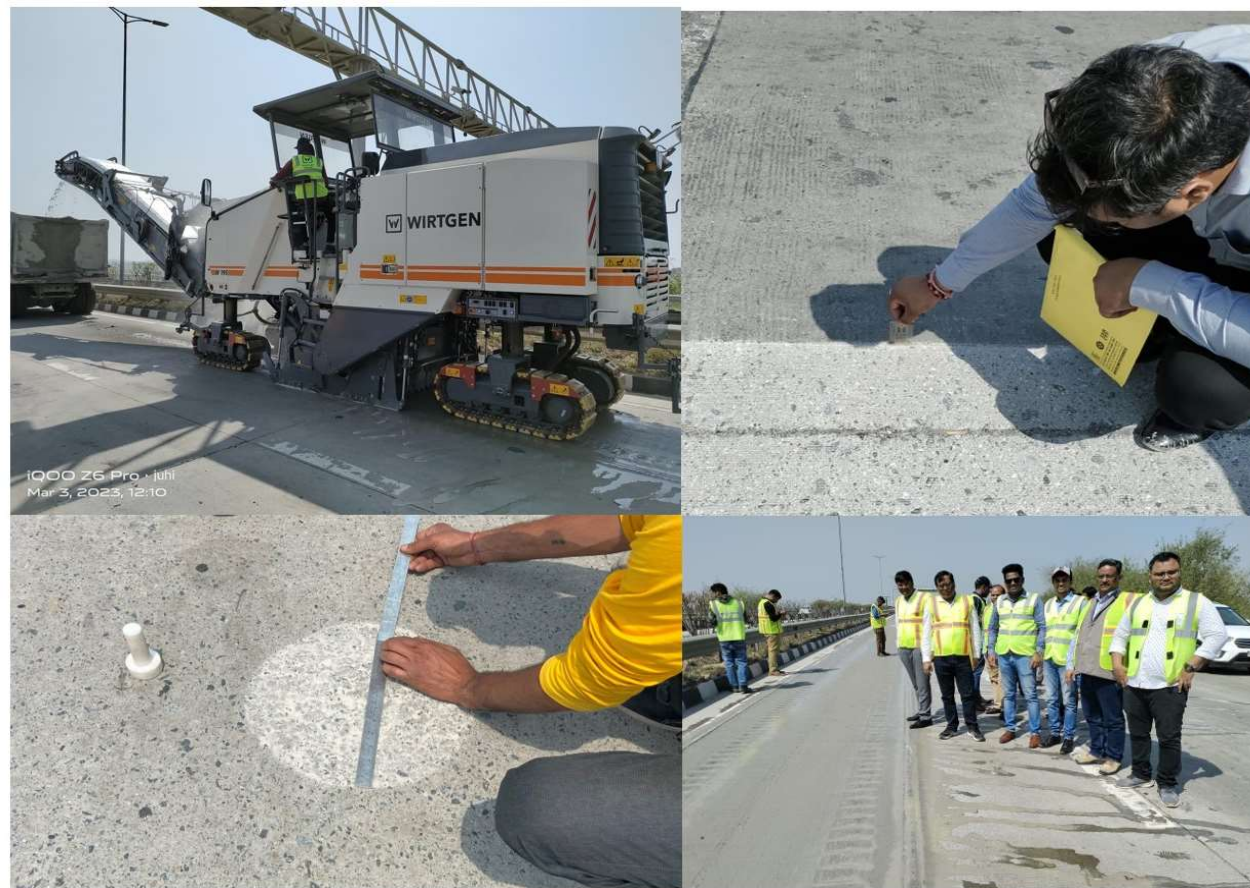
Measurement of texture depth after milling of the pavement

Lane wise Average MTD, after milling on 5th May 2023 and 7th August 2023 and Codal provision for new concrete road

Lane	Avg. MTD and range as on 5/05/2023, mm	Avg. MTD and range as on 7/8/2023, mm	Avg. MTD required at new concrete road, IRC:15-2017, MoRTH-2013
Outer	0.58 (0.54-0.65)	0.41 (0.35-0.48)	0.65-1.25 mm after six weeks of construction & before traffic is allowed*
Middle	0.53 (0.49-0.60)	0.36 (0.28-0.38)	
Inner	0.54 (0.44-0.63)	0.40 (0.30-0.43)	
Overall average	0.55	0.39	
			ASTM E 965, 1.5 mm for heavily trafficked areas

- * The average mean texture depth of the milled pavement slab measured on 5/5/2023 and 7/8/2023 varies between 0.53 and 0.58 mm and 0.36 and 0.41, which fails to meet the minimum requirement as given in IRC codes & the MoRTH Specifications even for a new concrete road.
- * A faster deterioration of the average mean texture depth (reduced from the overall average texture depth from 0.58 mm to 0.39 mm, which is 29% over three months) of the milled surface indicates the frequent milling requirement.
- * The methodology adopted for improving the riding quality of the road limits its adequacy for the safety of the users due to a faster deterioration of the milled texture depth on this kind of expressway.

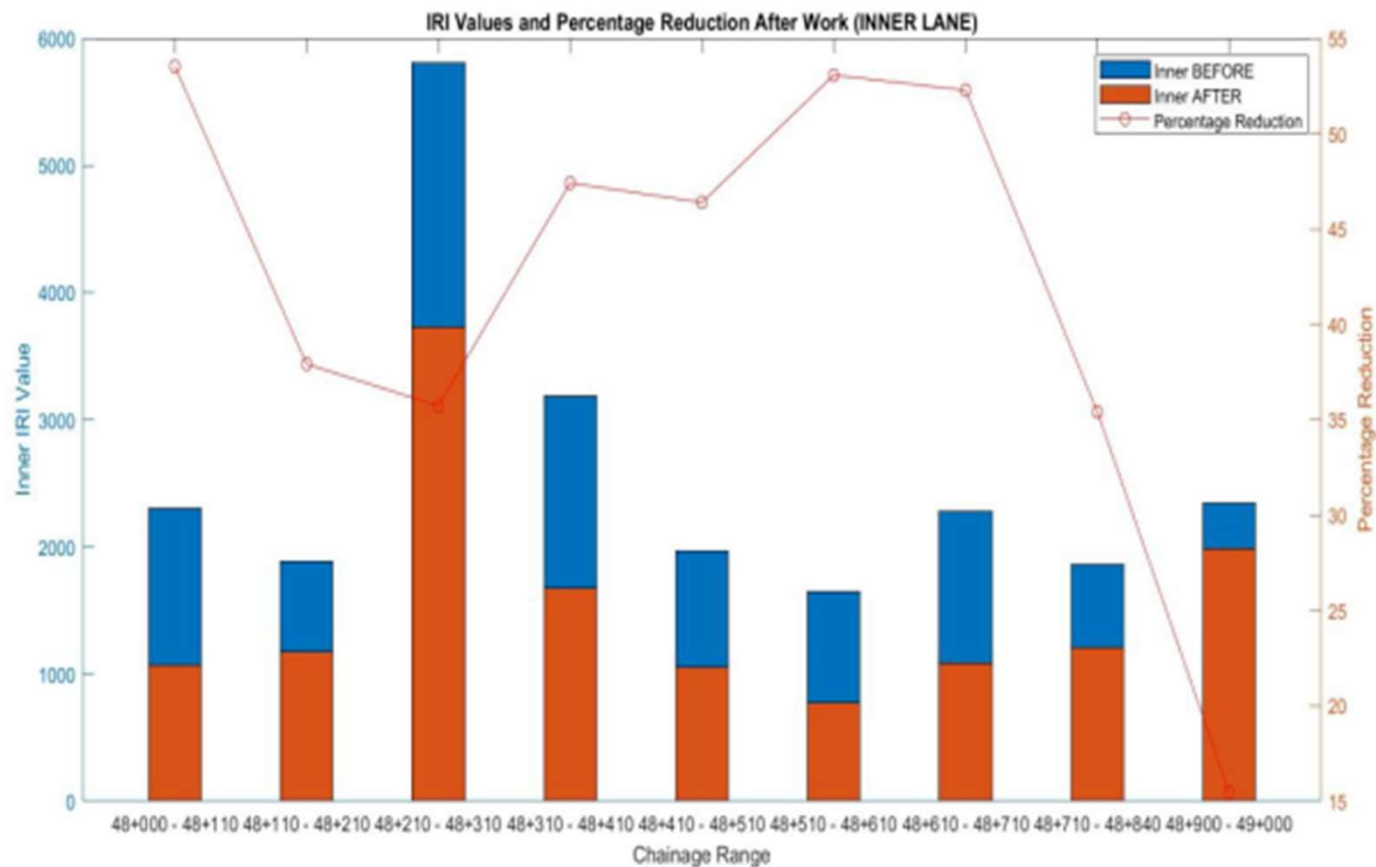
IRI values of the inner lane (before and after work) and percentage reduction

- * *The selected test section of 900 m was free from any structure including a cross-drainage work.*
- * *The methodology adopted for improving the pavement roughness effectively reduces the IRI at different levels varying from lane to lane and stretch to stretch. Out of about 900 m test section, 700 m has shown improved.*
- * *Despite the use of surface milling, some stretches of the test section (Chainages km 48+210 – km 48+310 (all three lanes) and km 48+900 – km 49+000 (middle & outer lane) remained in the category of unacceptable based on their IRI values for concrete pavement indicating the need for further interventions or adoption of suitable alternative strategies.*

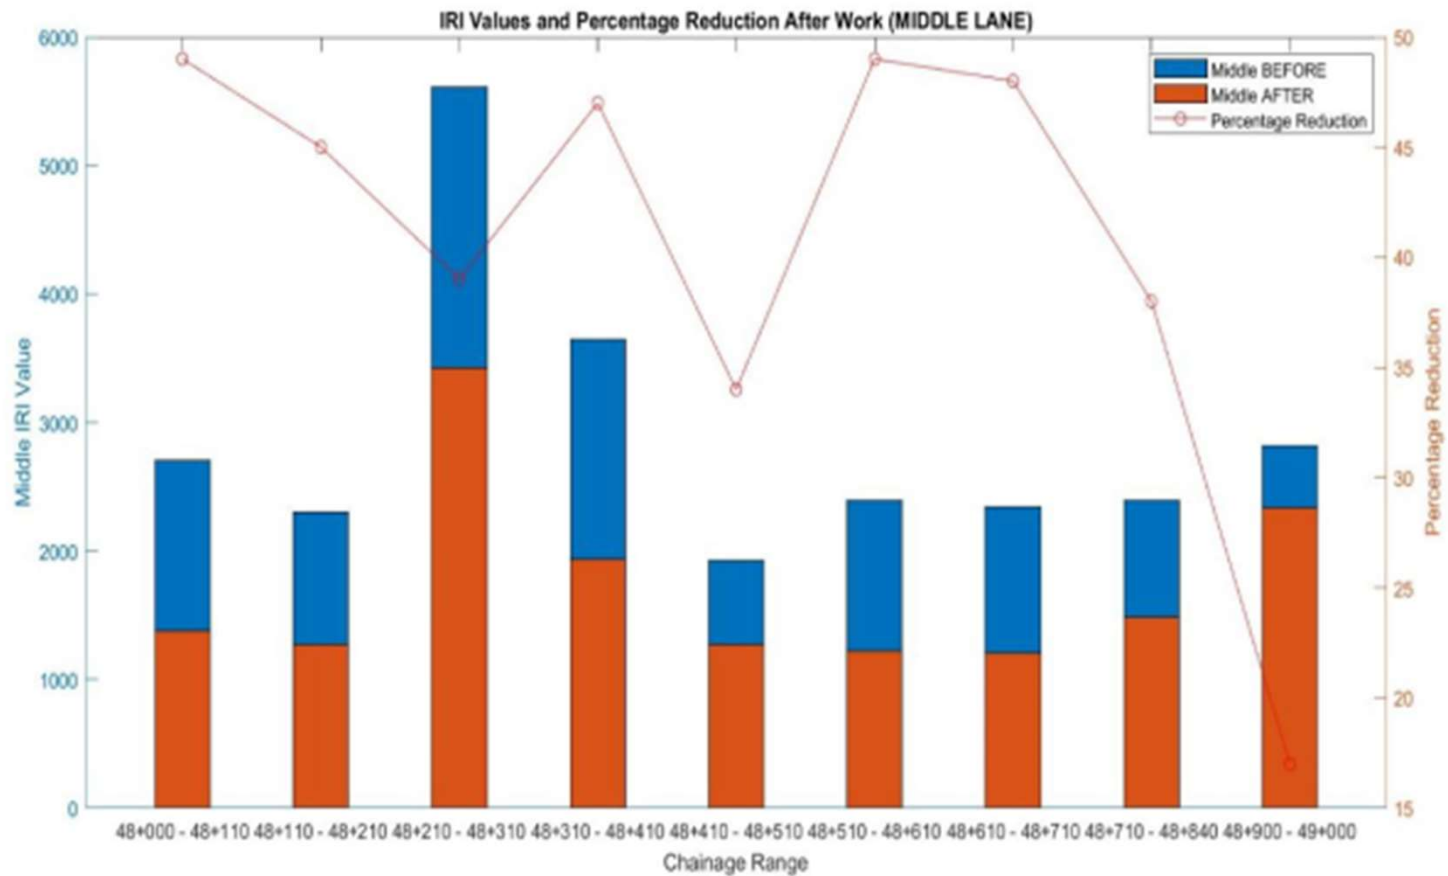
IRI values of the middle lane (before and after work) and percentage reduction

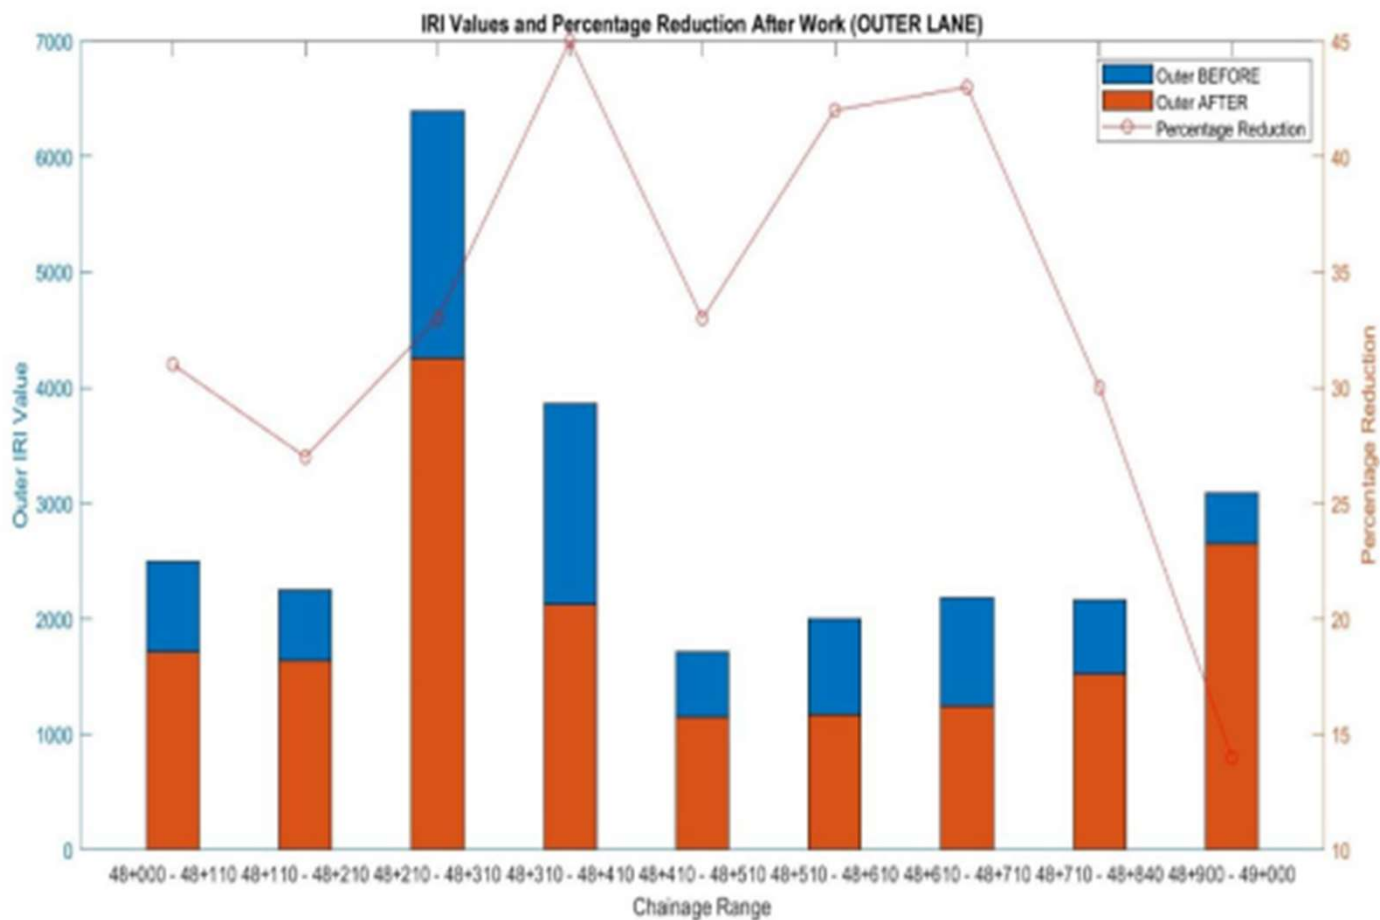
IRI values of the outer lane (before and after work) and percentage reduction
